Rebuilding The Transom On An Old Haines V-17 C

Do It Yourself
-with F&B!

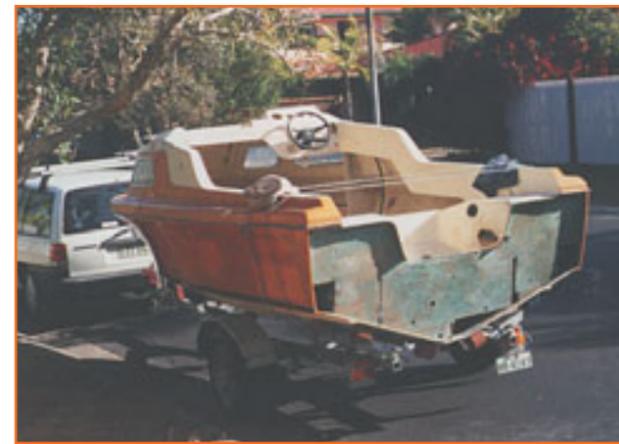
1 It did get a lot of strange looks on the highway. The owner knew that there was a bit of rot in the transom when he bought the boat but thought it was only a small patch. He cut it out but found more so just kept on cutting. He admits that he knew that working from the outside was a mistake, but couldn't see how he was going to get access from the inside. Since he thought he only had a small patch to cut out working from the outside looked like a good idea. But even if the damage had not been so wide spread, you really do have to get at it from the inside. Cutting a hole on the outside (even one smaller than this) will generally lead to a repair that not only looks ugly but is severely compromised in strength.

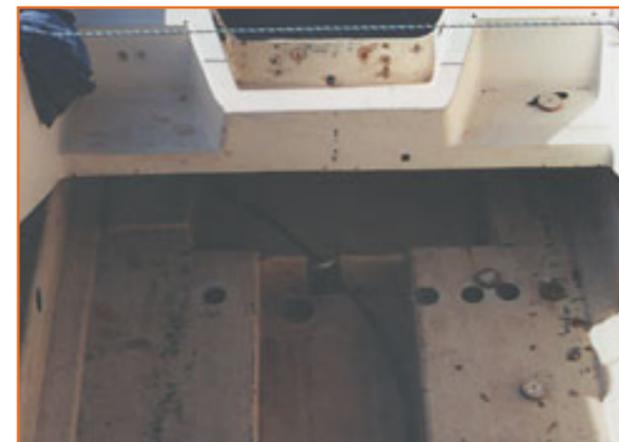
2 The rot didn't stop at the transom however. We drilled some inspection holes which you could also look upon as core samples. These showed that just about everywhere there was timber in the boat there was also dry rot. Notice that these were drilled with a hole saw not just a drill bit. A hole saw gives you a hole big enough to look into and the piece from the hole does really act like a core sample and let you have a really close look at the state of the timber. Make the hole the same size as a large screw-in bung fitting and you don't even have to repair the hole if you find there was no rot. Just fit a bung instead and you then have a permanent inspection port the check for water etc later on.

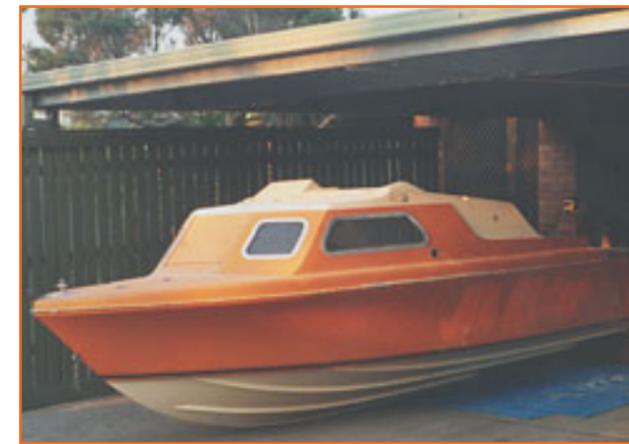
3 Ain't she pretty! Well I think so, anyway. Still one of the best looking trailerboats ever built in Australia. Notice however that she is off the trailer and sitting flat on her keel on solid, flat ground. You can't do any type of repair work like this with the boat on the trailer. Even on a relatively small repair the hull can get pushed out of shape by the rollers and skids. As you will see in later photos there really wasn't much left in the back end of this boat by the time we had finished anyway. There was no way we could have left it on the trailer.

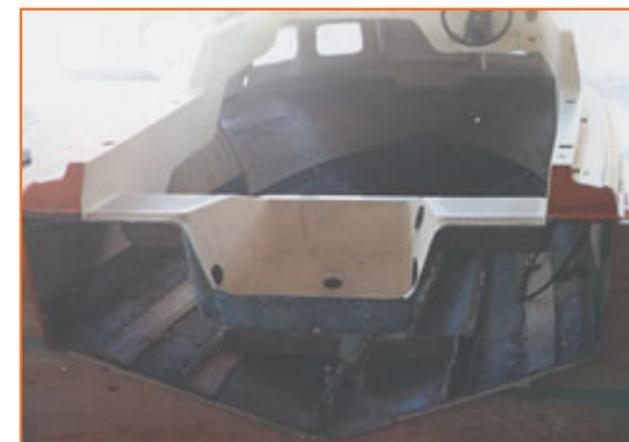
4 This photo was taken after I had sent the owner home to grind and cut for a few days. Most of the internal timber was rotten so it was decided to do a full internal rebuild while the transom was being done. Just be aware that if only the transom was rotten then there would not have been the need to cut out the floor and the structure underneath as has been done here. However, even if that had been the case we would still have taken out about half a metre of floor to give full access to the transom from the inside. The frame supporting the boat was made before anything was cut out and is needed to preserve the shape of the boat and keep what's about to be left of the back of the boat solid while we work.
