PLAN 'B' . . . An Exceptional Renovation

Innovative bunch, the West Aussies. When boatbuilder Tim Gilbertson's local lake dried up, and he couldn't take the kids skiing, they decided to go fishing along the coast instead, hence - you guessed - Plan B! This is all about taking a hulk that costs zip - and making it work with good ol' fashioned elbow grease.

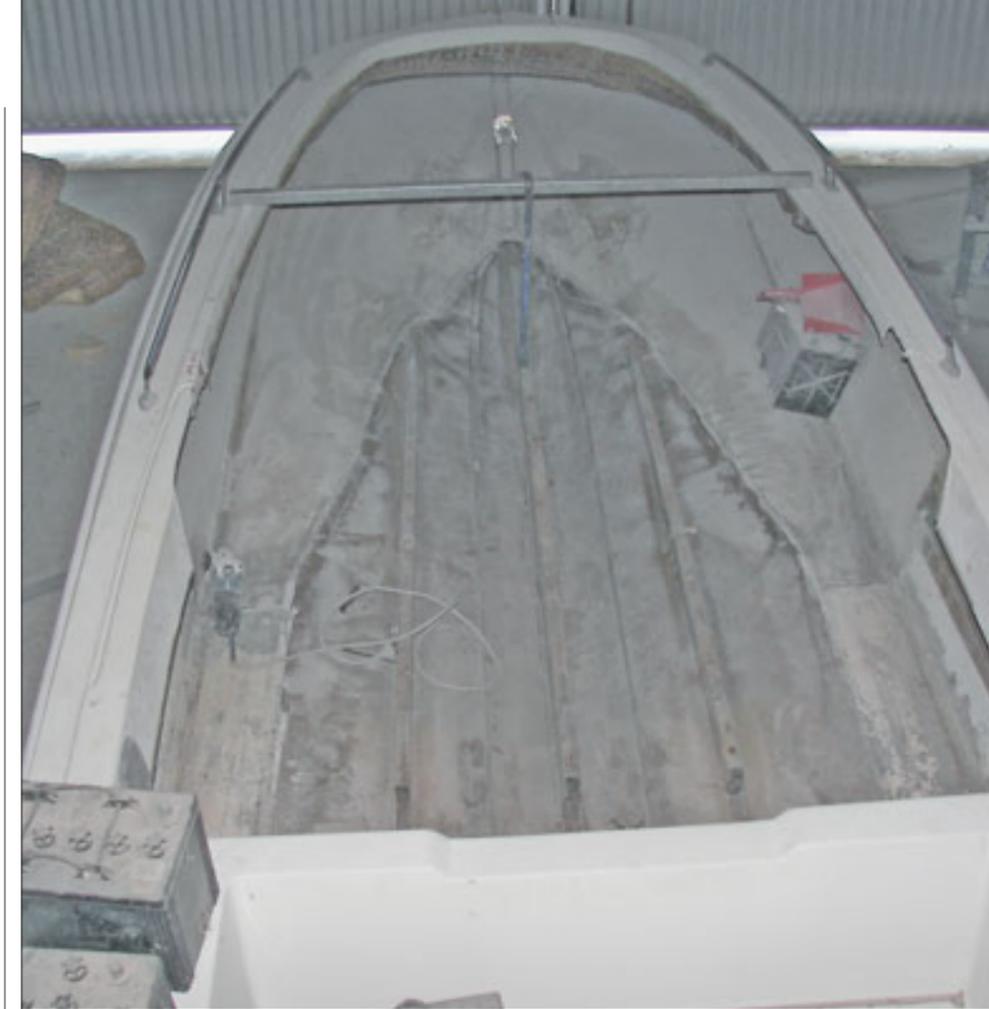
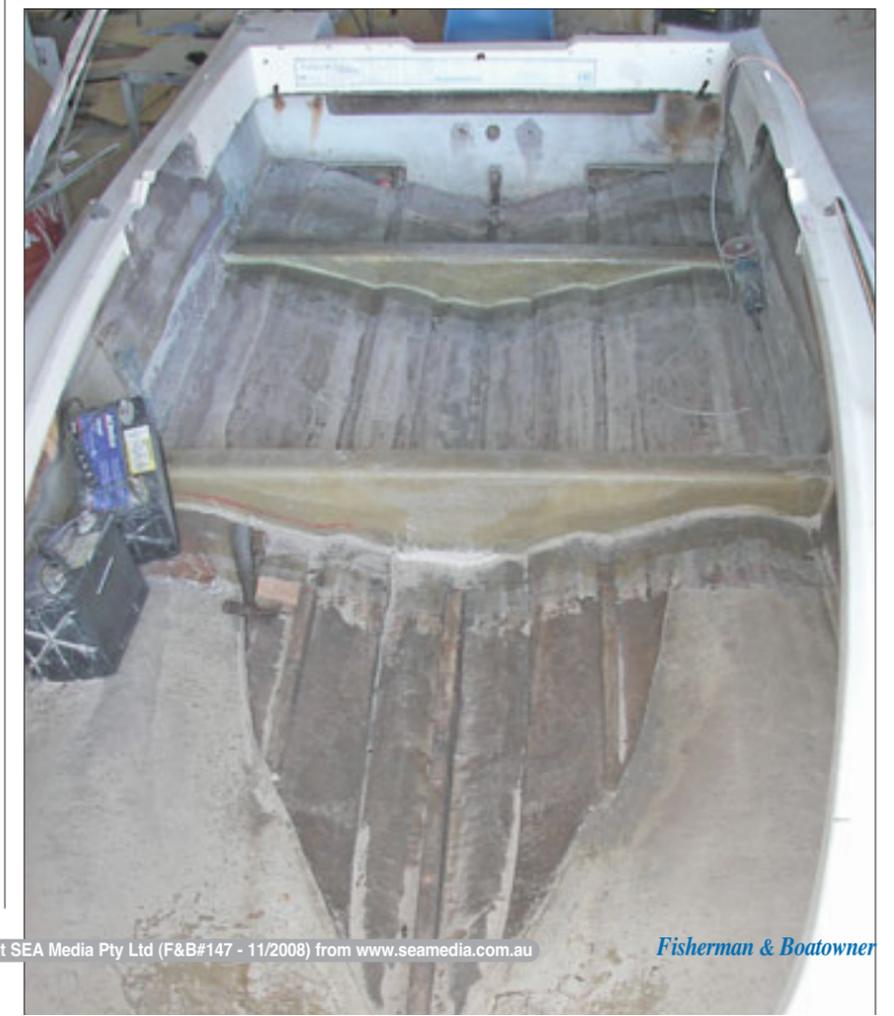
The hull is secured to four points and using batteries, wedges and a spirit level I fiddled until I got rid of most of the 20mm of twist, the last 5mm just wouldn't come out. This stage is extremely important, the hull must be level in all directions before the first frames go in. Once the first frame goes in the hull stiffens up rapidly.

The hull is thoroughly ground out before reskinning starts, any defects are found and dealt with. The re-skinning is only a light layer of glass although all stress areas keel, chines and spray strakes are given an extra layer of double bias cloth. The hull gave me a pleasant surprise at this time, whoever built the boat initially had done an A grade job. All lay ups were of correct thickness and properly rolled out. This would make the renovation considerably easier and quicker.

I established the height and location of the first frame. Again, this is most important because this one frame will impact on the rest of the project. I split the level of the floor amidships, the fore-part will be under the bow rider, or as it turned out the casting deck. By raising this frame I was able to
