The 'Little' Things

(Or, the REAL cost of setting up a second hand rig properly!)

According to FNQ cruising fisho Don Gilchrist, buying the pre-loved rig is only the beginning - and he should know: he's had enough of 'em, culminating in this classic from Signature, the original 'variable deadrise' deep vee - the 2250.

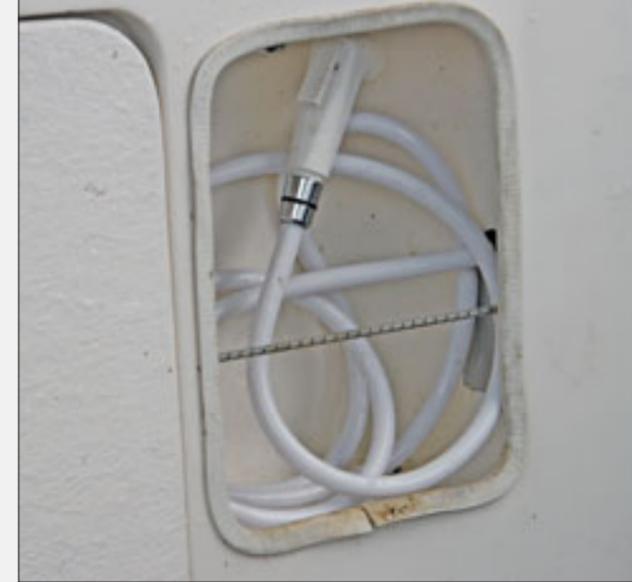
The shower recess was there when I got her, it was just empty. Filling it with something serviceable has been worthwhile.

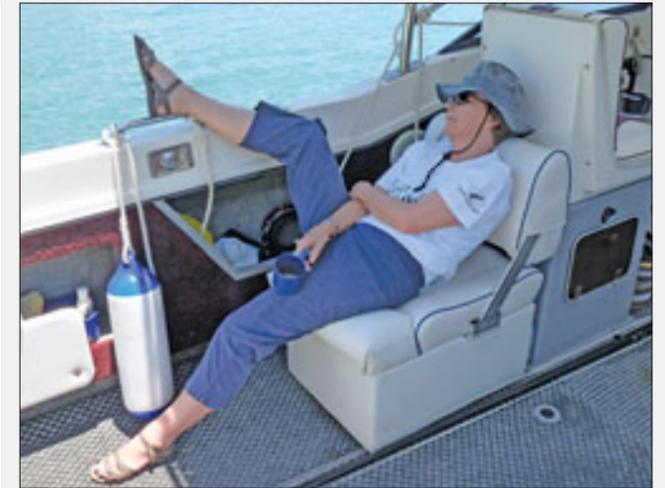
One of our seat/storage units doing its job. It also houses some fishing gear and our fresh water tank - see pic on page 29.

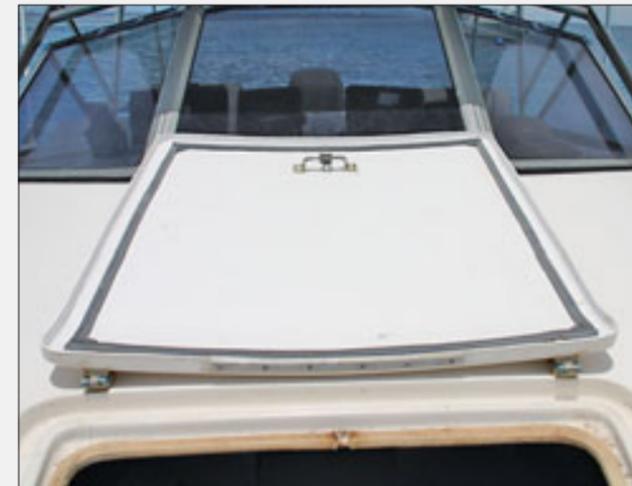
The repaired front hatch with mouldy, sagging headliner replaced by white flowcoat. A metal reinforcing strip repaired an area where extra GRP was not an option. The hinges had to be lifted by 10mm as it was the camber of the cabin top that caused some of the damage to the hatch. Above: The strut and shock cord limiter have been a useful addition.

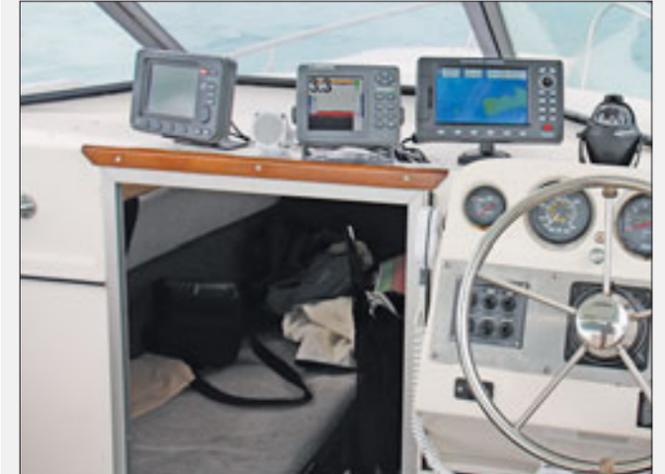
When we added some updated electronics we kept the old plotter and remounted it for the observer. Pilotage inside the maze of reefs that is the GBR needs all the assistance possible. The old plotter is monochrome but still quite functional.
